EXTENT OF CONTAMINATION DETERMINATION, BUILDING DECONTAMINATION GUIDELINES, AND BENCH-SCALE REMEDIAL TESTS FOR THE CHEMICAL COMMODITIES INC., SITE, OLATHE, KANSAS

December, 1989

FINAL REPORT

Roy F. Weston, Inc.

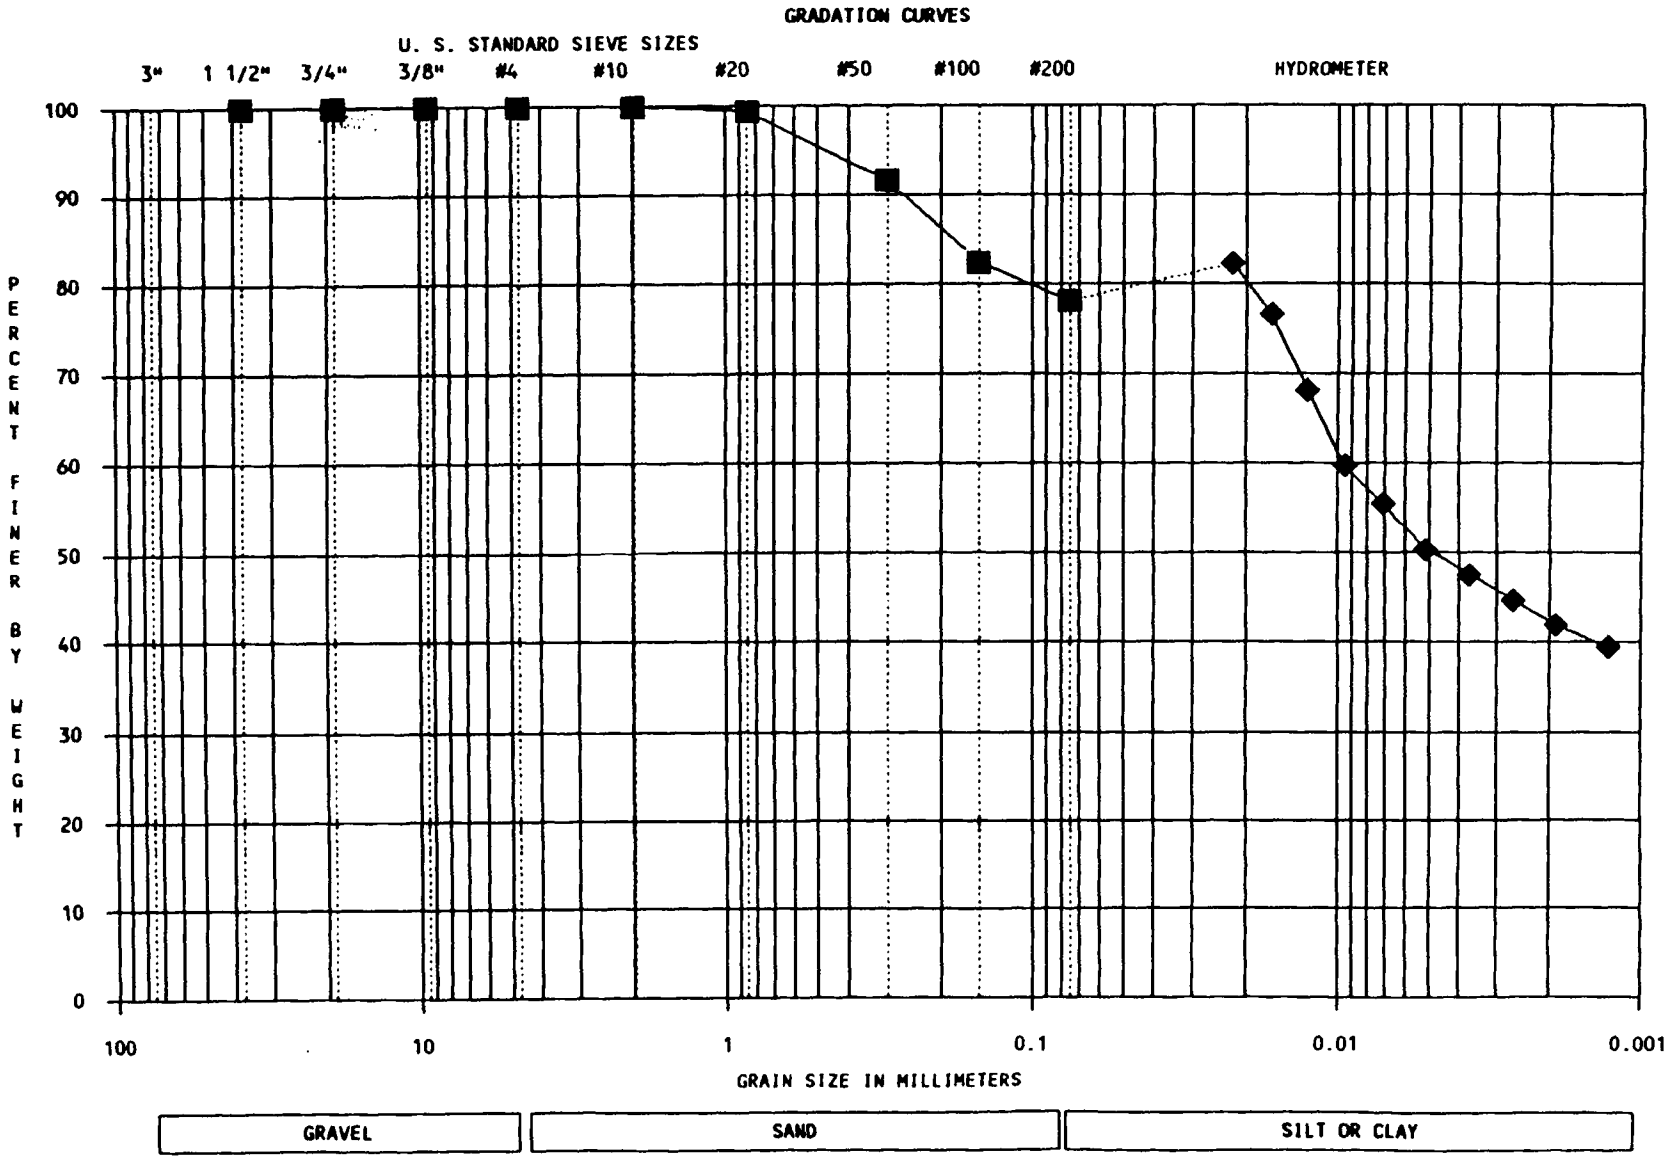
Figure 1. Soil particle size distribution, depth 0.5 to 2.5 feet

Both samples were found to be highly plastic clays with the overwhelming majority of particles below #200 mesh (75 um). In addition, the CCI soils have a low hydraulic and pneumatic permeability. Tables 6 and 7 and Figures 1 and 2 show the particle size distribution for the samples. Sample #001 contained 78.1% of its particles below #200 mesh. Furthermore, 97.8% of sample #002 particles were smaller than #200. Both samples exhibited higher plastic behavior. These characteristics are an example of a soil containing a high clay content.

COMMENTS:
NA = NOT APPLICABLE
SOIL EXHIBITS VERY COHESIVE AND PLASTIC PROPERTIES AND IS VISUALLY IDENTIFIED AS A HIGHLY PLASTIC CLAY

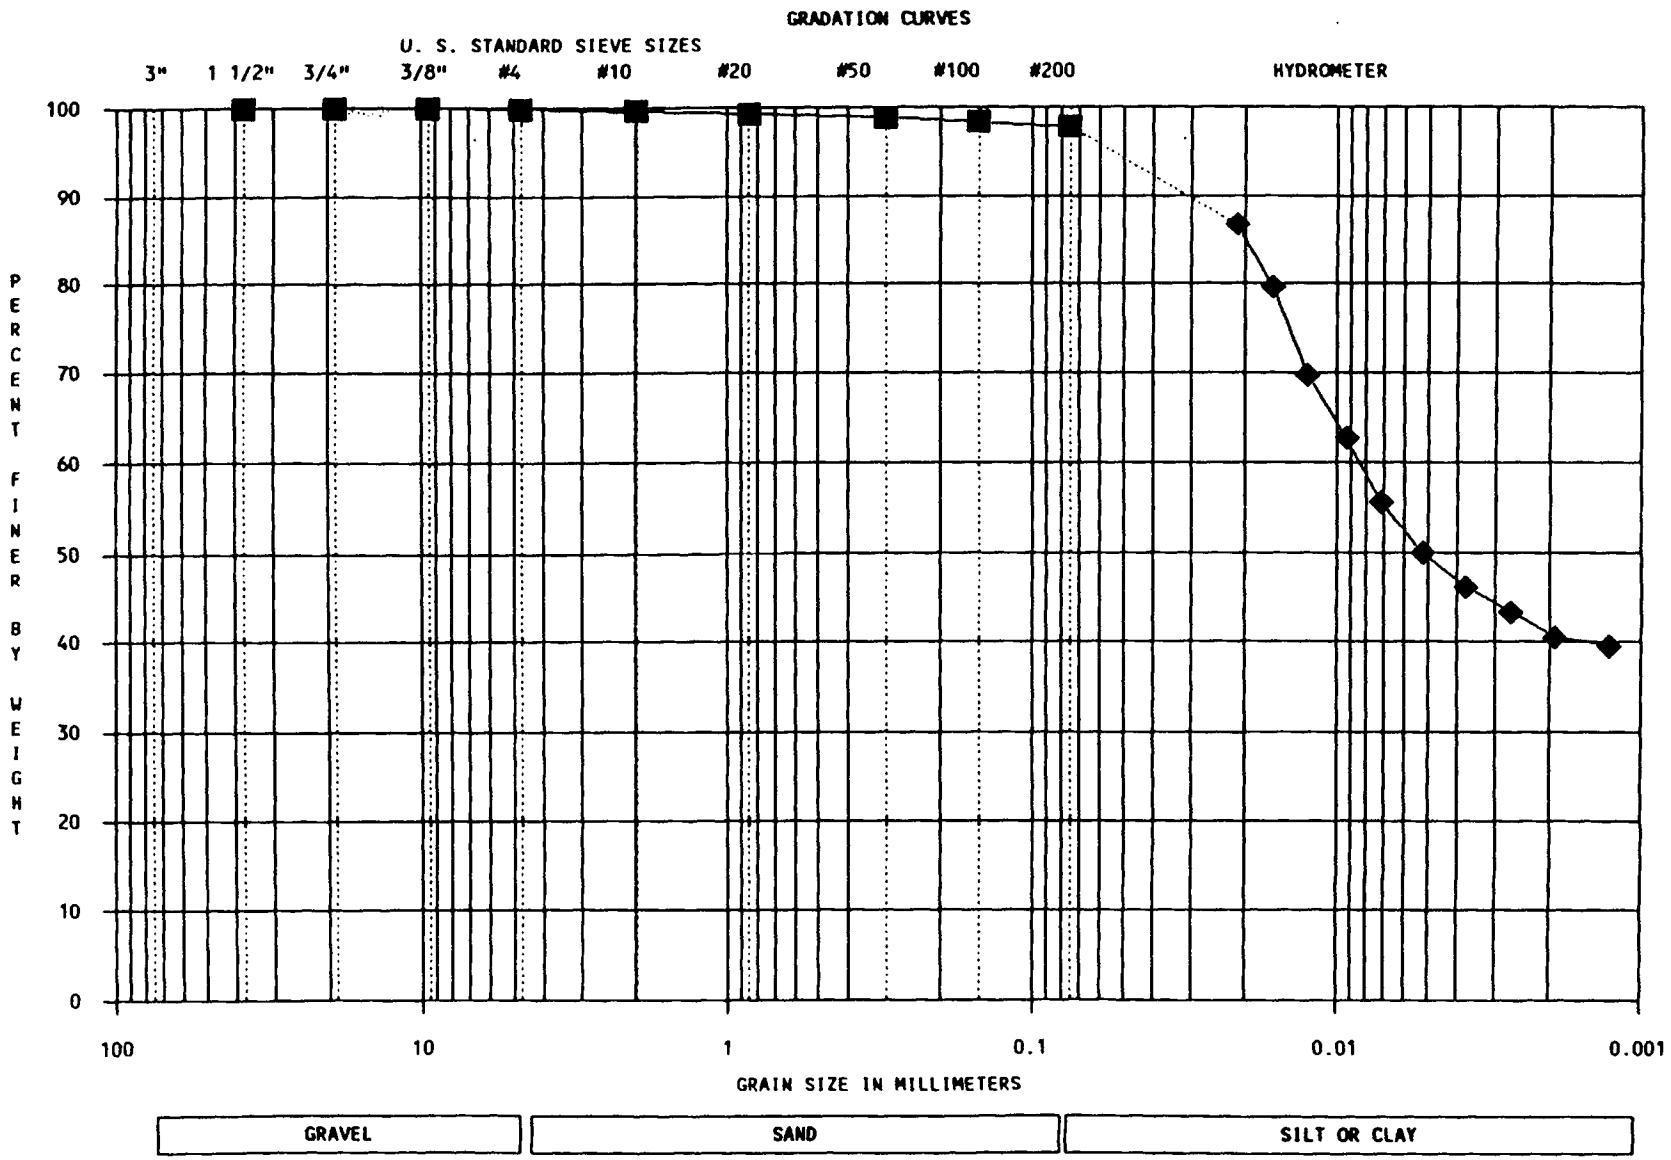
Figure 2. Soil particle size distribution, depth 2.5 to 3.5 feet

COMMENTS:
NA = NOT APPLICABLE
SOIL EXHIBITS VERY COHESIVE AND PLASTIC PROPERTIES AND IS VISUALLY IDENTIFIED AS A PLASTIC CLAY

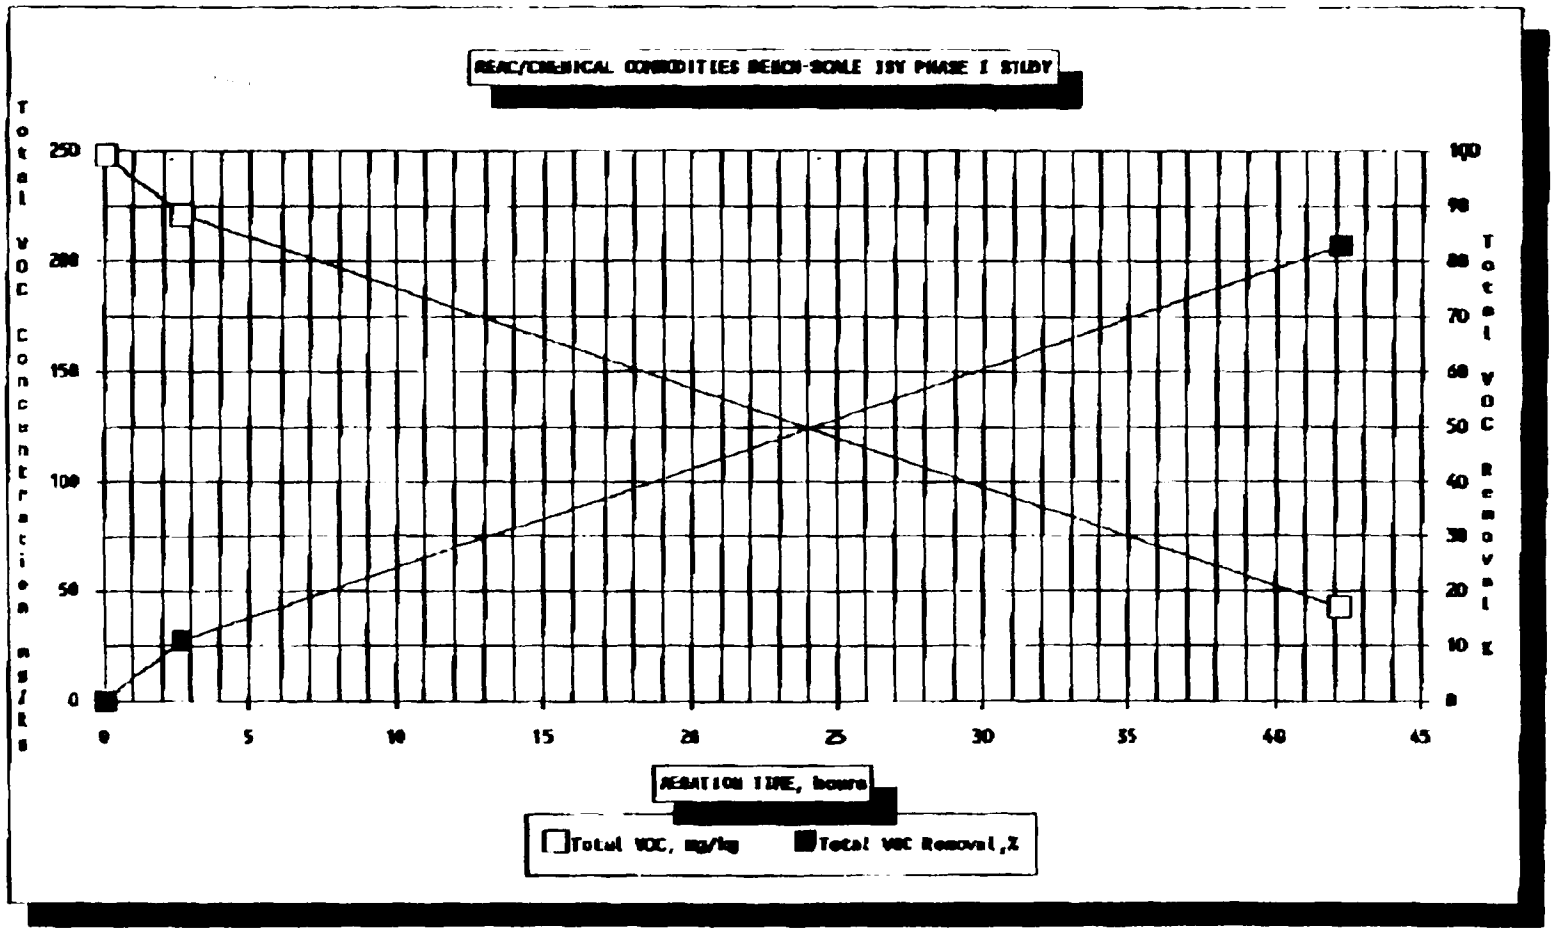
FIGURE 1 : Total VOC Concentration and Removal versus Aeration Time

Bench-scale investigations found that ISV removed 82.8% of the VOC contamination after 42 hours of operation. During the test, nearly 24 pounds of CCI soil was aerated with over 106,000 cubic feet of ambient air. Several of the site's major contaminants had lower removals than VOC. Trichloroethene was reduced 69.9%, tetrachloroethene 72.8%. The reduction of the VOC in the soil is mirrored by the reduction of VOC in the outlet air in the unit. Immediately after start-up, the air-borne VOC concentration was 220 ppm/v. However after three hours, the VOC levels were 4.2; at 42 hours down to 0.3 ppm/v.

Bench-scale investigation found that ISV was not a viable treatment option. The reduction in VOC was low for an optimistic system such as the bench-scale unit. Less favorable reductions of VOC contaminants would result with a large scale ISV than the bench-scale unit. Therefore, the modest reductions of VOC during the bench-scale tests resulted in an unfavorable recommendation for this technology. The very low hydraulic and pneumatic permeability of the CCI soil also provided little hope for the potential use of ISV, although the scientific literature reports the removal of contaminants in soils with hydraulic conductivities ranging from 10^{-3} to 10^{-6} cm/sec [4]. The CCI site soil ranges 2 to 3 orders of magnitude less permeable. Therefore, the combination of the bench-scale test and the geotechnical test indicate that ISV will not be a viable treatment option at CCI.

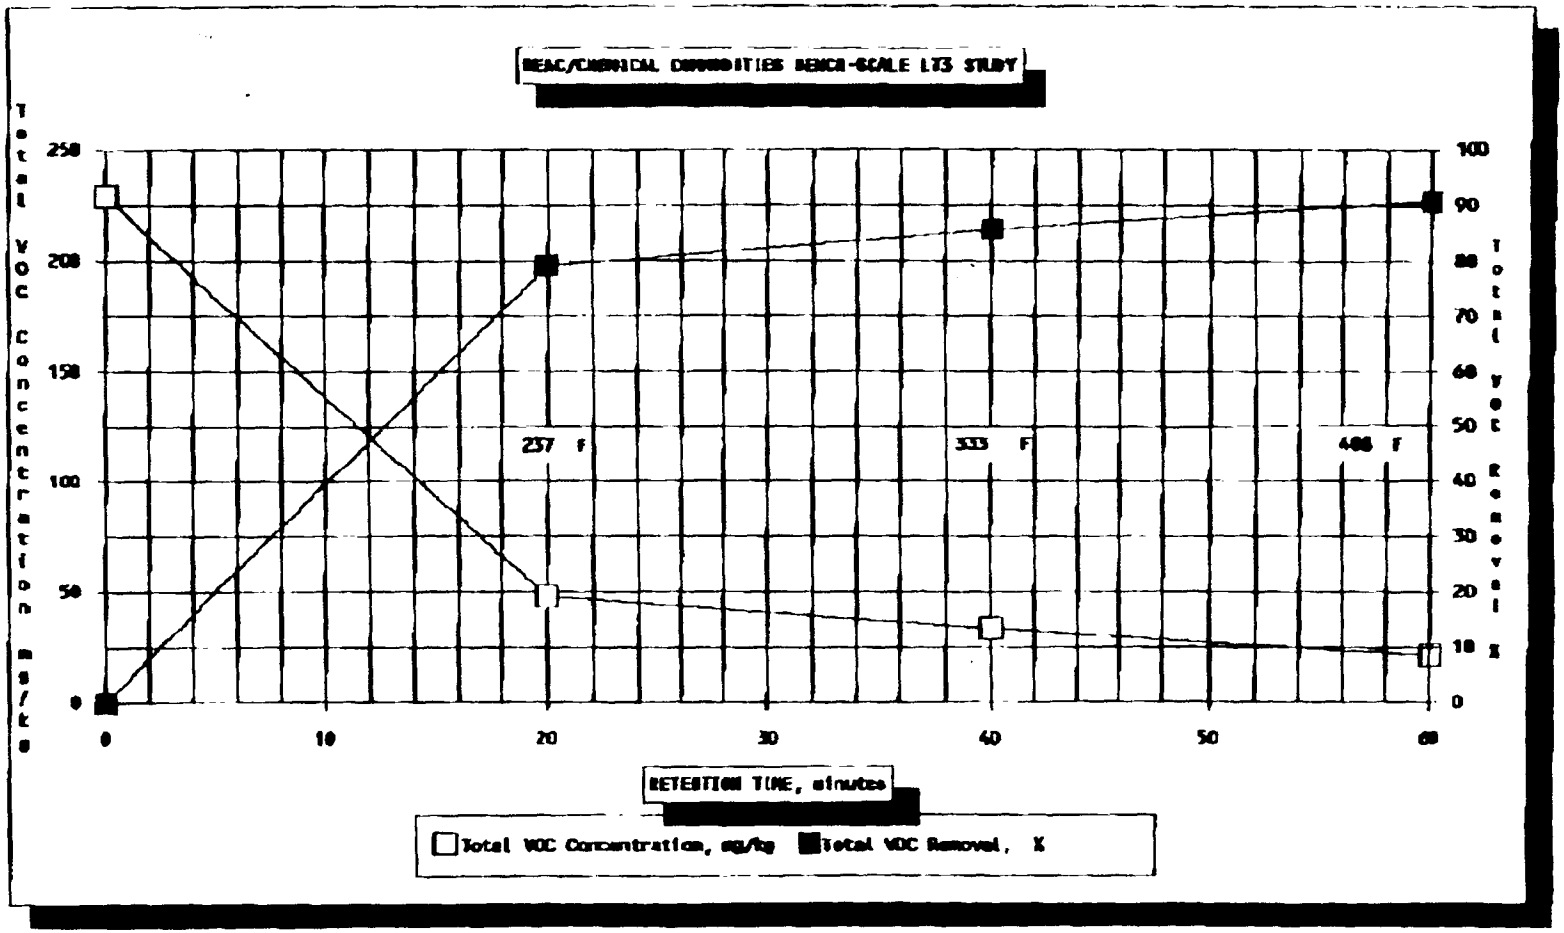
FIGURE 3 : Total VOC Concentration and Removal versus Retention Time

the 400°F maximum temperature which can be achieved by the full-scale LT3 unit. LT3 removed nearly 90.7% of the soil-bound VOC contaminants, from 226 to 21 mg/Kg (after the 3rd pass). Some widely distributed contaminants had higher removals then the total VOC: trichloroethene, 96.2% and tetrachloroethene, 96.0%. However, some compounds had high residual concentrations in the soil: acetone, 14.7; 2-butanone, 2.2; and 4-Methyl-2-Pentanone, 1.7 mg/kg.

Bench-scale tests conducted for LT3 resulted in an approximate 91% removal of VOC's which was less than that required to meet the 1 mg/kg level recommended for the site (> 99.5% removal required). The fact that acetone and 2-butanone exhibited residual concentration higher than in the untreated soil could be the result of either a chemical transformation or laboratory contamination. A sufficient quantity of soil was not available for additional tests to evaluate either of these theories. Thus, the remediation efficiency of LT3 cannot be accurately determined at this time. When the high residual concentration are factored out the removal efficiency is still slightly less than the recommended level. Since CCI is bordered on three sides by residential houses and LT3 is an excavated soil technology, the residents would have to be temporarily relocated or a plastic dome erected over the work area to eliminate or reduce the risks of fugitive VOC emissions during remediation. Since both of these options are costly, the performance of the LT3 system does not appear to warrant this additional treatment cost.
